Situation Photo Log

Thursday, September 20, 2012

Kalamazoo River / Enbridge Spill

Prepared by:
Matthew Haak
START-USEPA
Situation Unit Leader

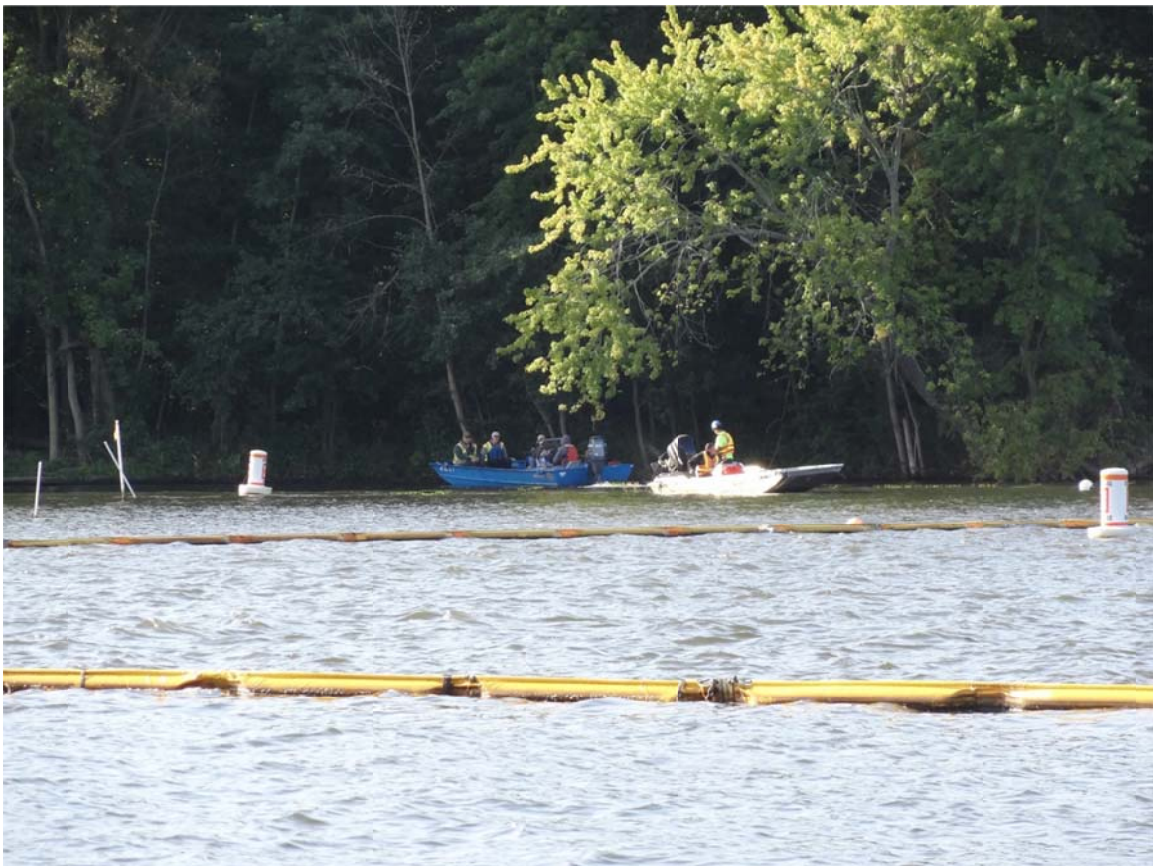
24. Morrow Lake Delta MP37.75 observed a crew deploying CSD.

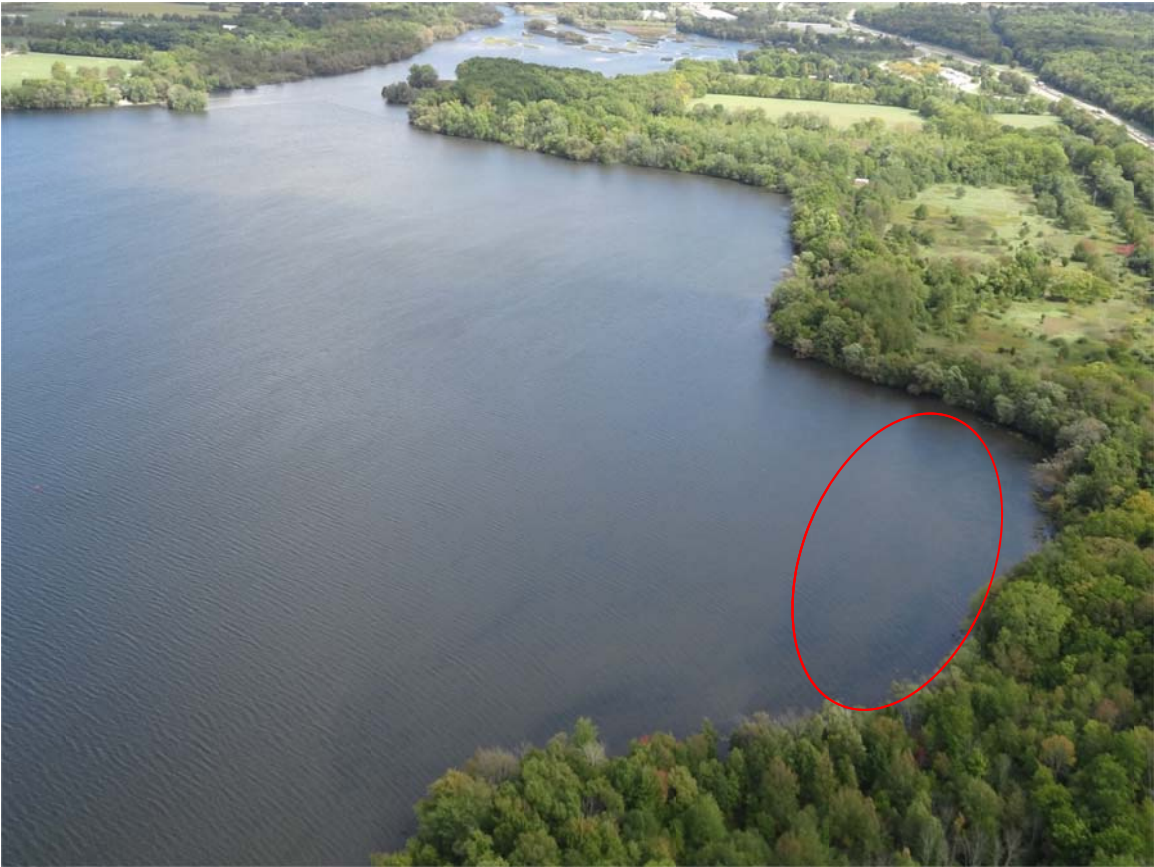
25. Morrow Lake south cove area where sheen was observed.

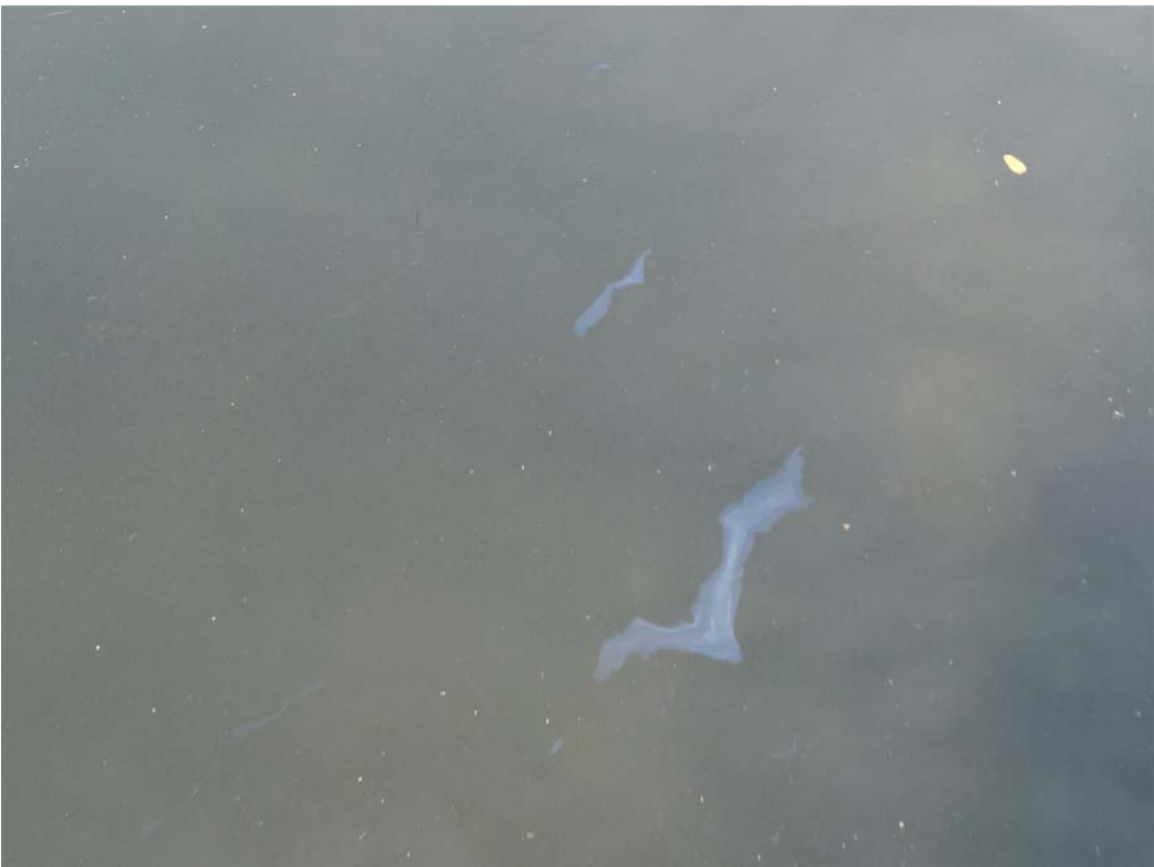
26. Morrow Lake south cove observed sheen, operations was notified.

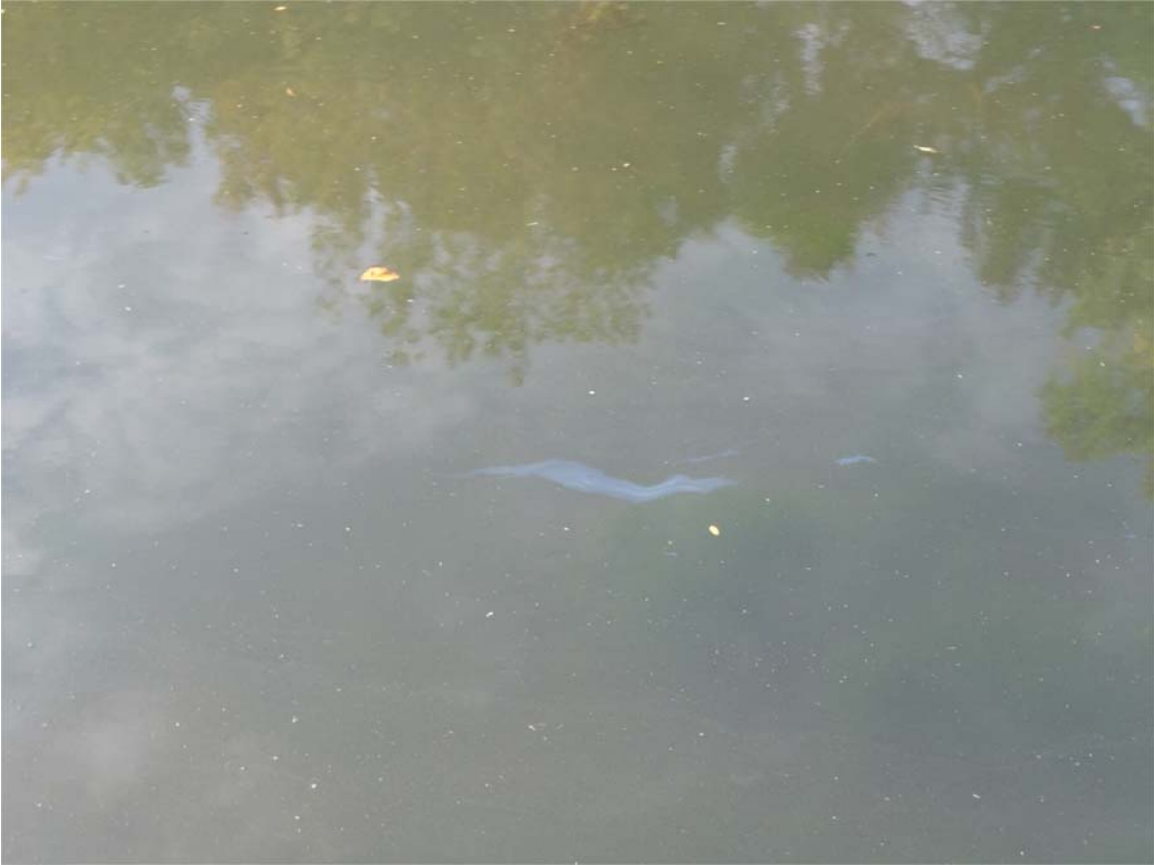
27. Morrow Lake south cove observed sheen, operations was notified.

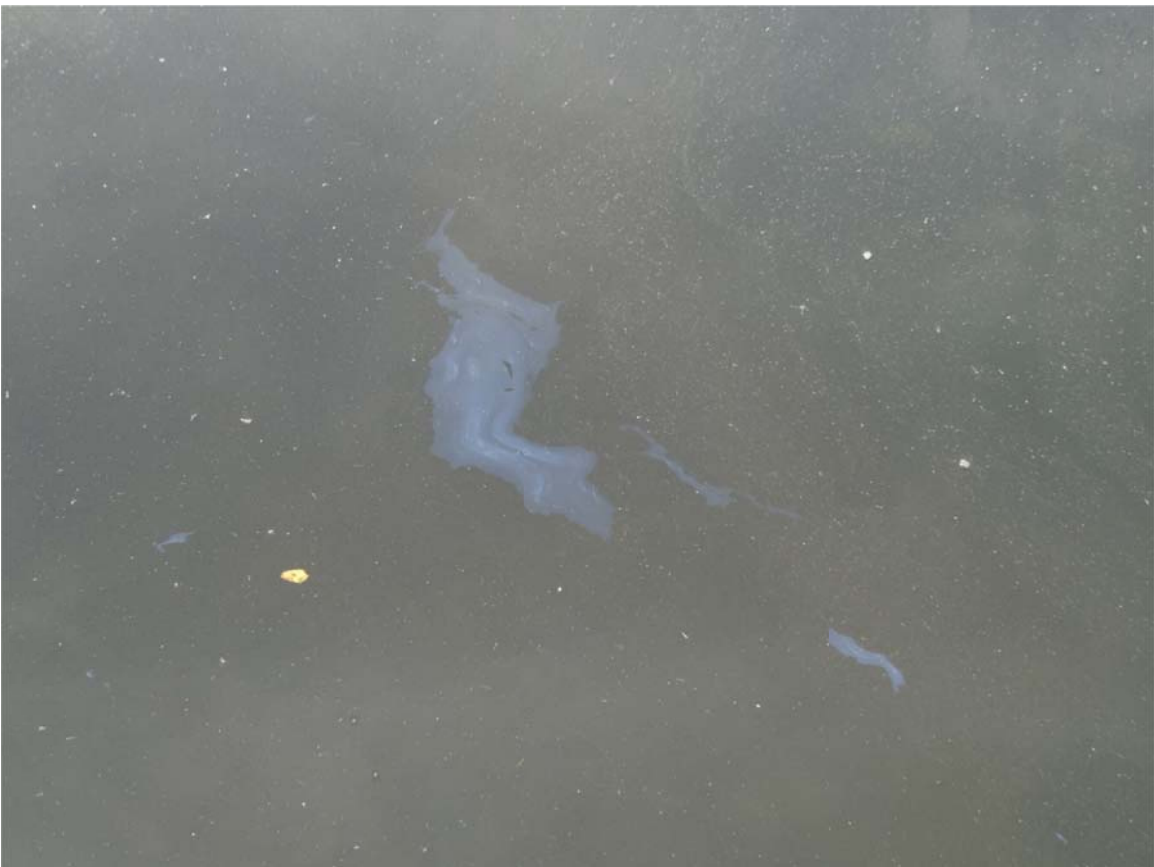
28. Morrow Lake south cove observed sheen, operations was notified.

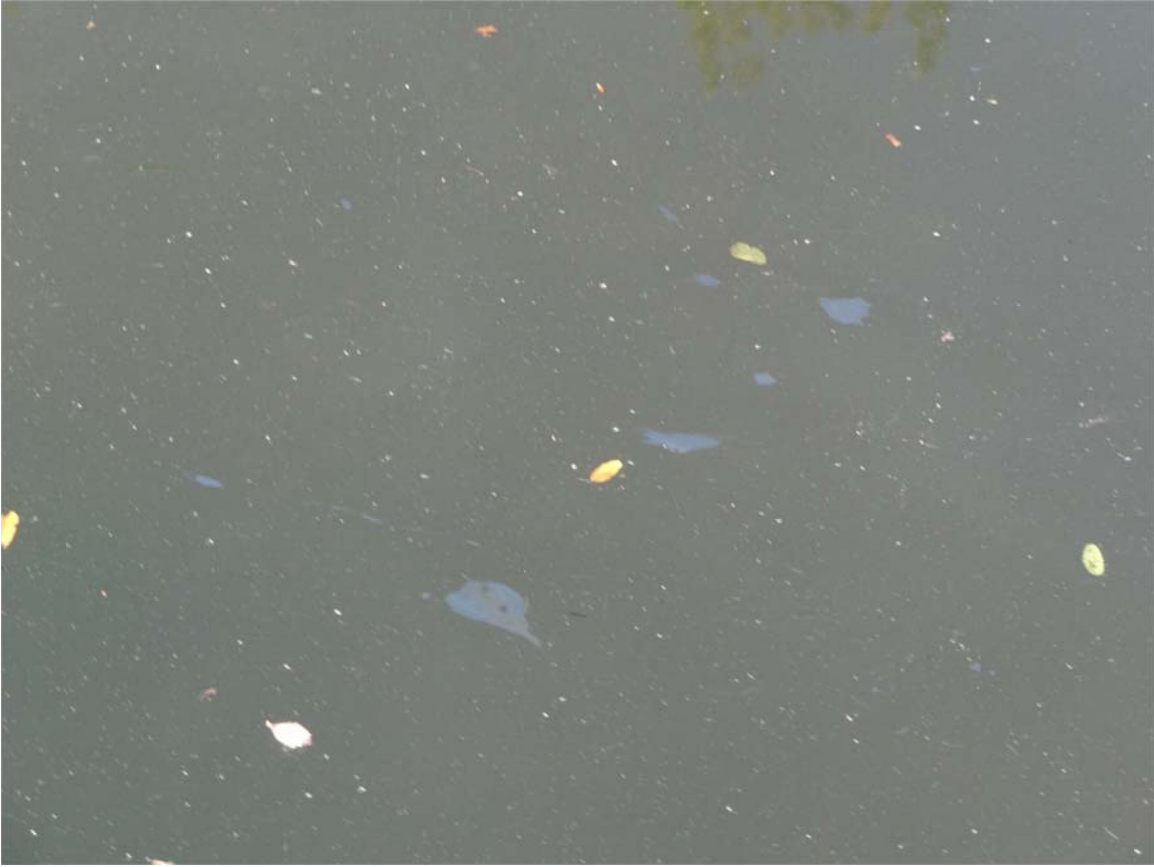
29. Morrow Lake south cove observed sheen, operations was notified.

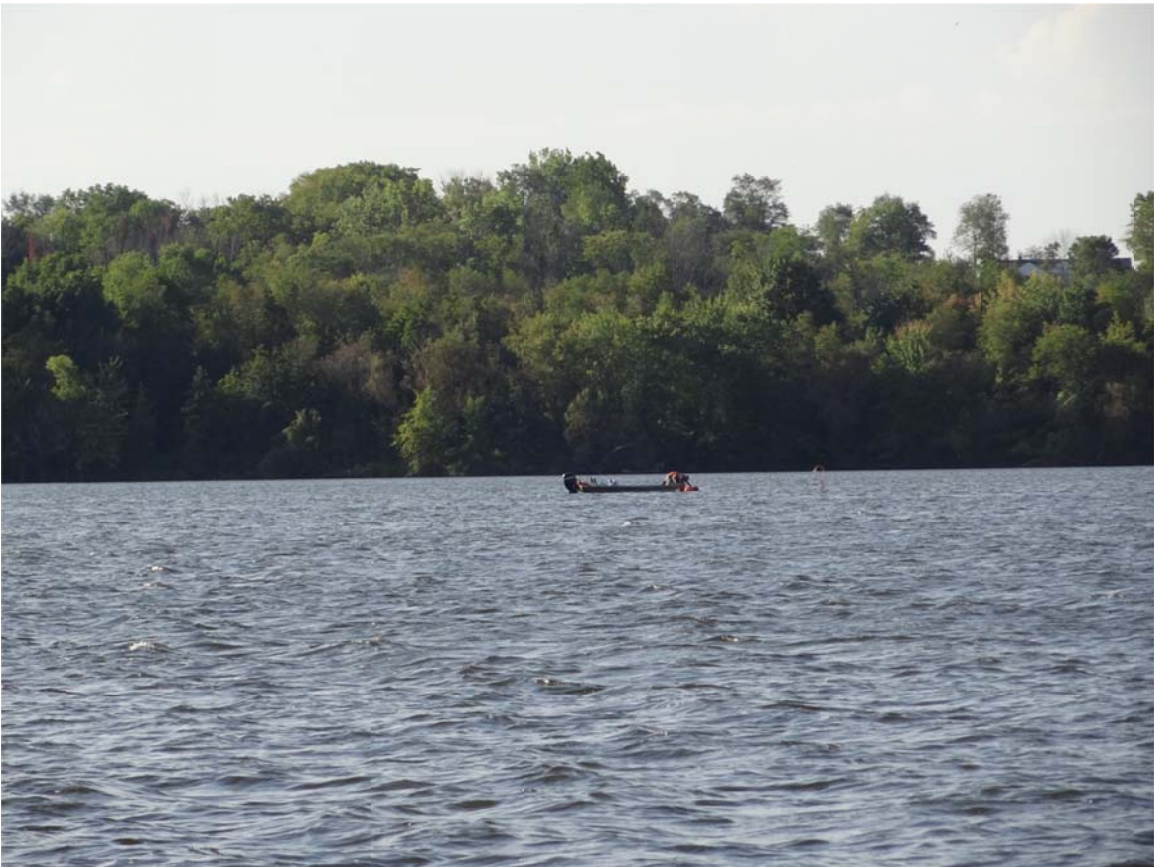
30. Morrow Lake observed a Walling Tube maintenance crew.

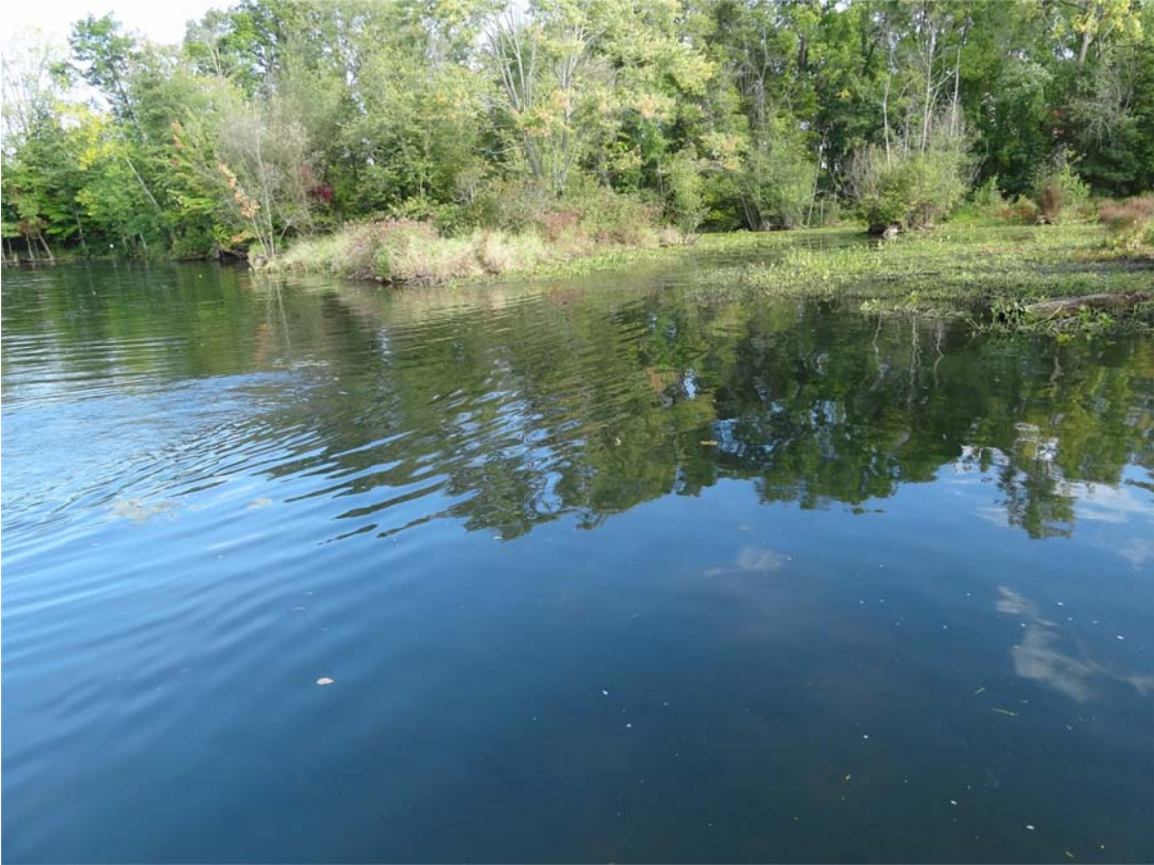
31. MP36.5 RDB area where sheen was observed, operations was notified.

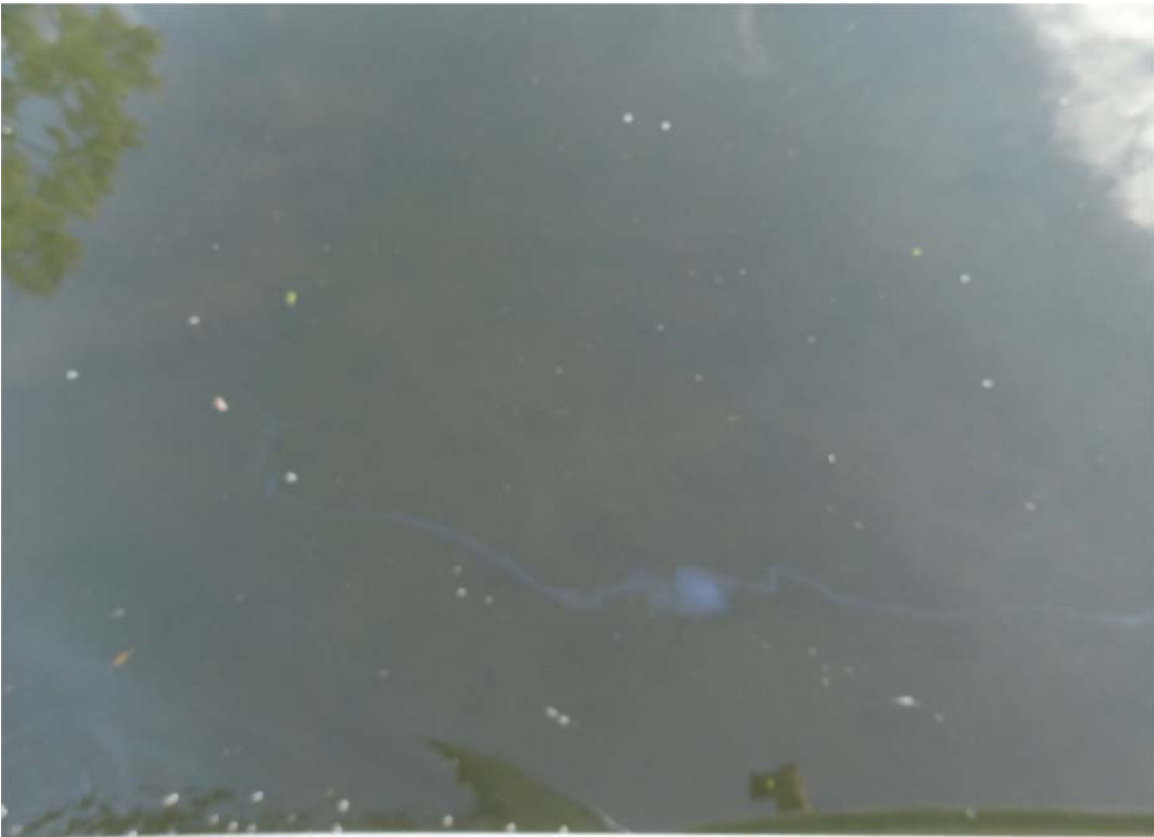
32. MP36.5 RDB sheen observed.
